**City Hall Salisbury  
Malthouse Lane, Salisbury  
SP2 7TU, UK**

**Suspended Plaster Ceilings  
Inspection**

Prepared for  
**Kier Workplace Services**

Job No: H199006

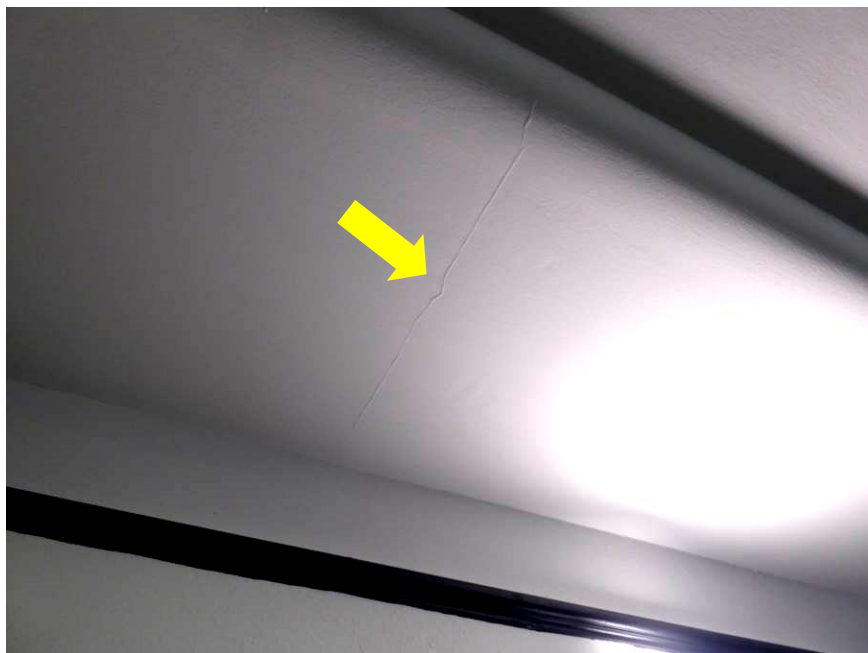
Cracking was seen intermittently, mostly along the South external wall and at approximate 4.0m centres. The cracking was below the painted surface and so not active / live.

Photo 7 – crack in Foyer ceiling.

- 5.1 In the Foyer area, provide safe access to the void above ceiling, to inspect whole area and assess full condition of ceiling's substructure, cast plaster panel attachments and plaster key attachments in the cracked areas.

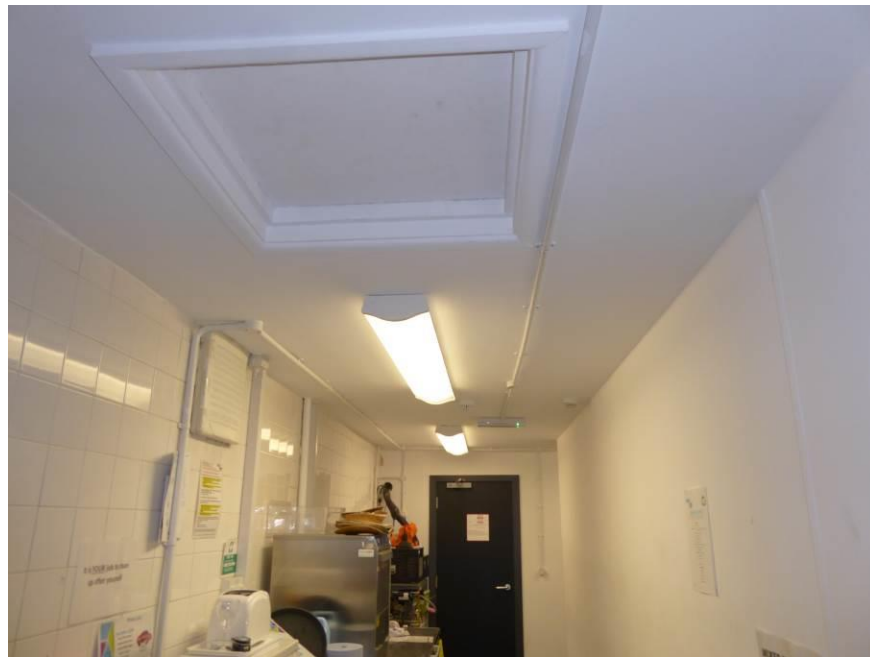
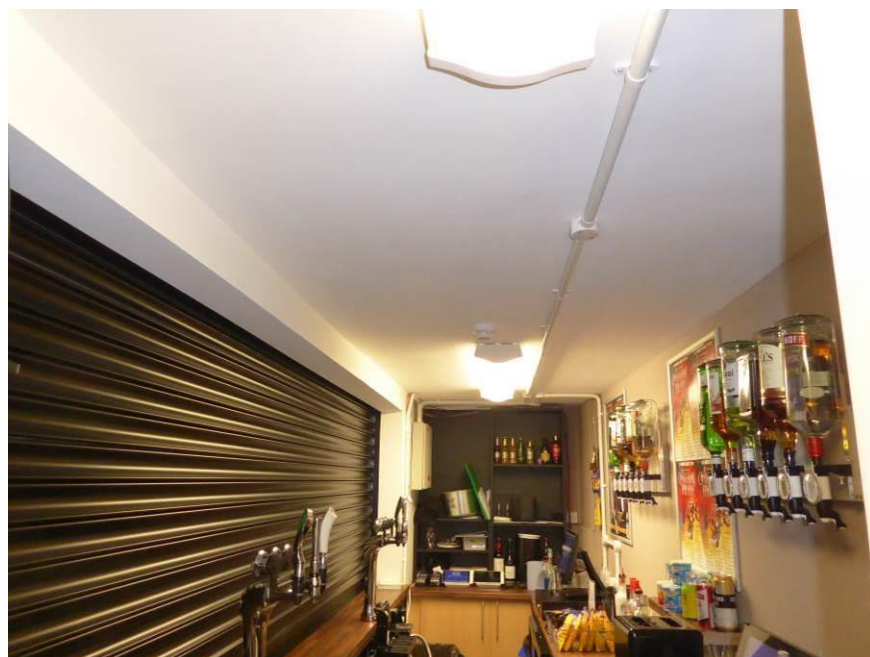
placed at approximately 1080mm centres. These bars were spanning between external wall and the wall separating Servery from Foyer, on overall distance of approximately 3.5m. They were suspended in the mid span with ties (see photograph above). Beneath the ceiling there was partition wall installed up to the underside of the ceiling and likely providing support at the mid-span of the bars as well. In the centre of the 3.5m span the ceiling was deflected at approximately 30mm, which is above the acceptable serviceability limit. Presumably the deflection occurred before partition wall installation.

Photo 8 and 9 – ceilings over the Servery and the Kitchen.

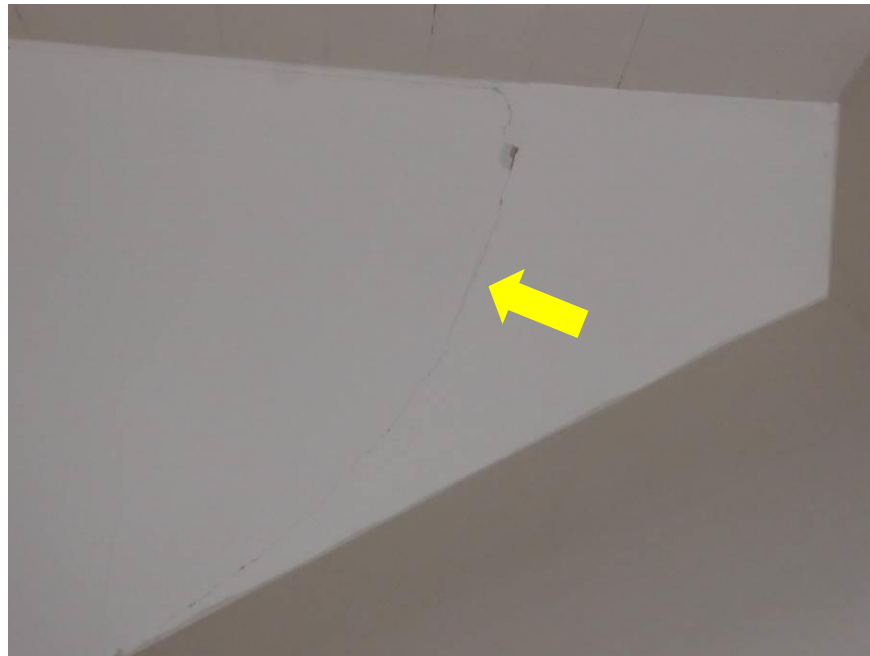
Cracking to left-hand side and right-hand side of the stage was noted. It appeared to be at the junction of historic suspended ceiling and modern ceiling infill. The immediate surrounding plasterwork was firm to applied pressure and sound.

Photo 24 – crack to the left-hand side of the stage.

It is likely that the above alterations had some impact on the decorative panels of the ceiling, causing the cracking and defects (hollow panels). The two cracks noted on right-hand side and left-hand side of the stage are not structural as the plasterwork is firm in crack surrounding. It is likely that the cracks occurred at the junction between the historic ceiling and the modern replacement ceiling, due to different materials used for construction.

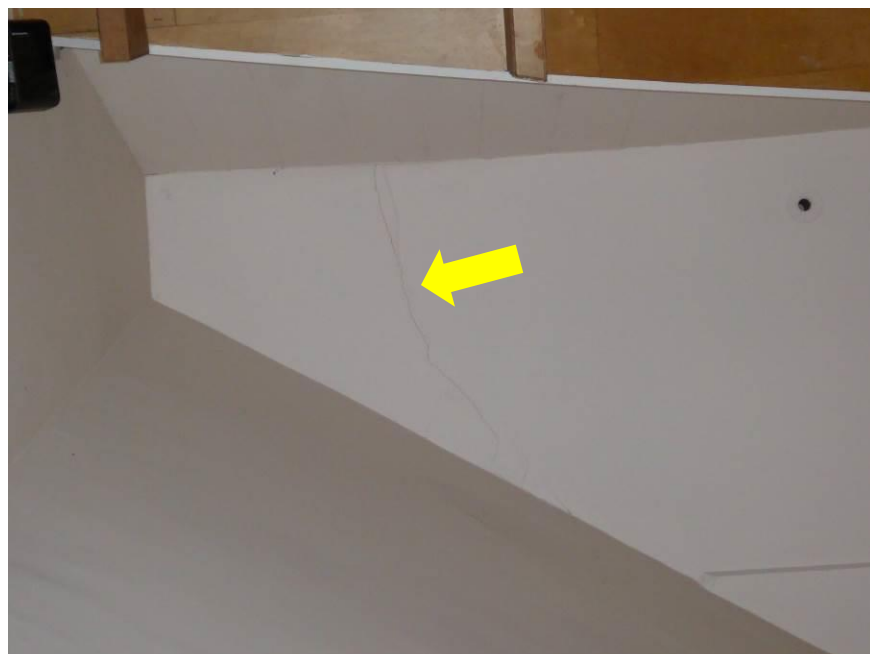
Photo 25 – crack to the right-hand side of the stage.

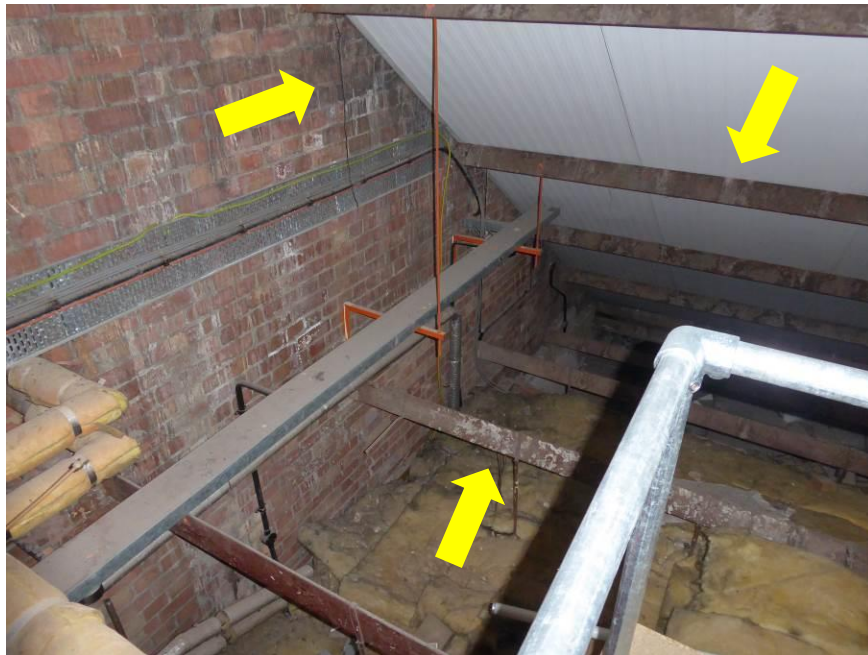
Staining on supporting angles and purlins have been noted, which can indicate water penetration issue prior to roof covering replacement. Corrosion of purlins' bearings onto the external wall has been noted, together with cracking and displacement of brickwork.

Photo 28 – staining on supporting angles (secondary beams and purlins) and wall.

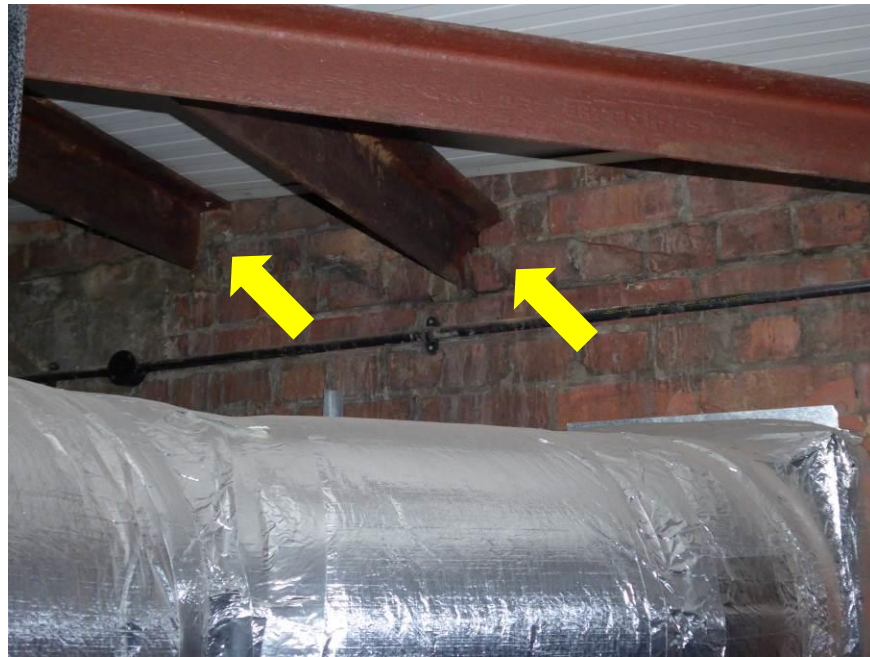
Photo 29 – surface corrosion of purlins bearing in external wall.

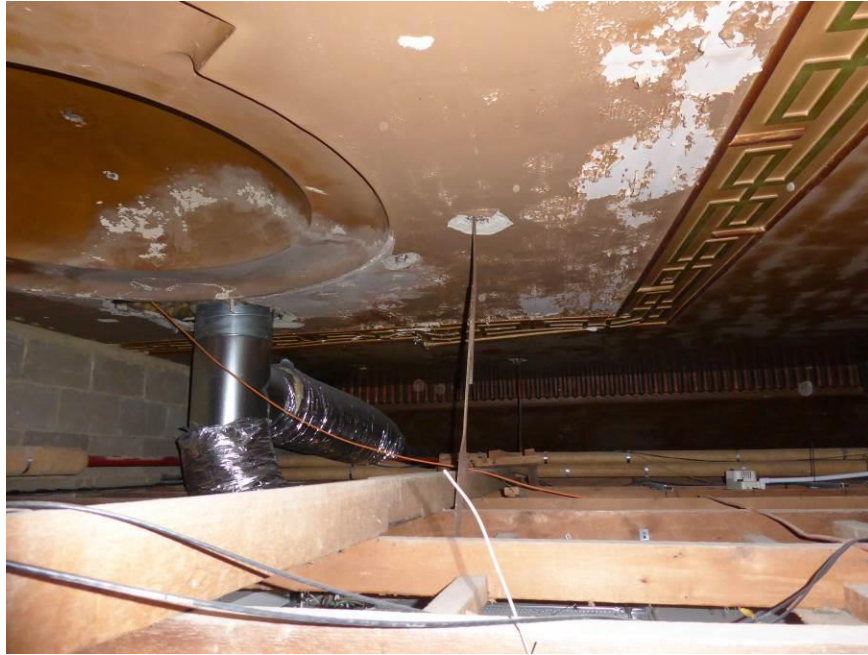
Numerous apertures were formed within existing ceiling, where hangers had been installed to support the timber subframe for the lightweight, tiled suspended ceiling. Openings for ventilation ducts have been cut in the historic suspended ceiling as well.

Photo 30 – The underside of suspended ceiling over Alemein Room.

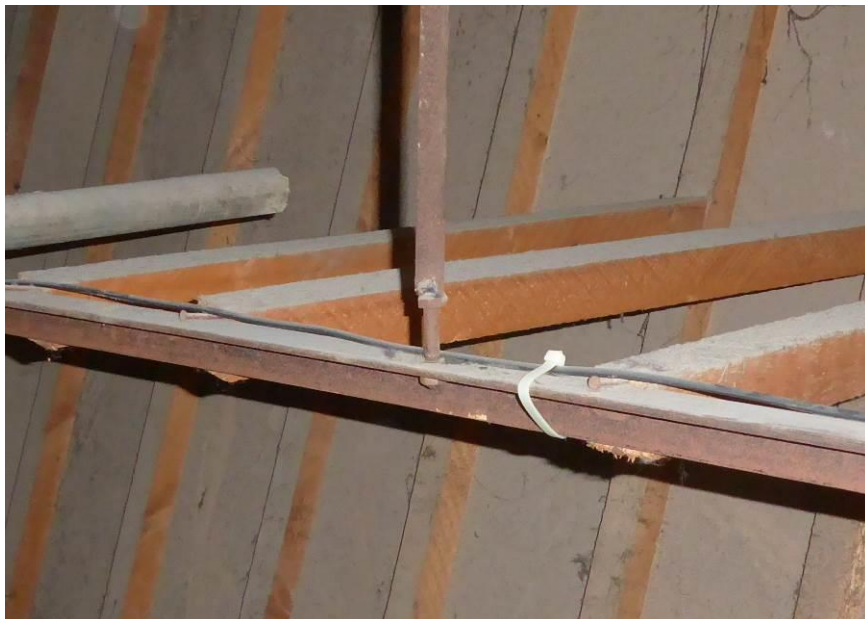
- 4.6 The modern ceiling and lighting platform were suspended of the historic supporting (roof) structure, which we find to have sufficient capacity. The timber structure forming the platform is sufficient to transfer the loadings on the platform. The flat bar and angle ties used to suspend the platform structure have sufficient tensile capacity, but the connection details are not adequate and in future may cause failure of the platform structure. The welding of hardened steel bolt to mild steel flat bar, as shown on picture below, does not provide full strength and may be susceptible to fracture.

Photo 31 – tie connection in the lighting platform’s suspension system.

We also noted un-secured bolts in these connections, which presumably increase stress on surrounding ties and connections. In our opinion the suspension system used for the lighting platform requires detailed assessment to confirm its viability.

- 5.6 The construction details of the modern lighting platform next to the stage must be investigated and assessed in details. Remedial works may be required to provide durability of the suspension system and prevent failure in the future.

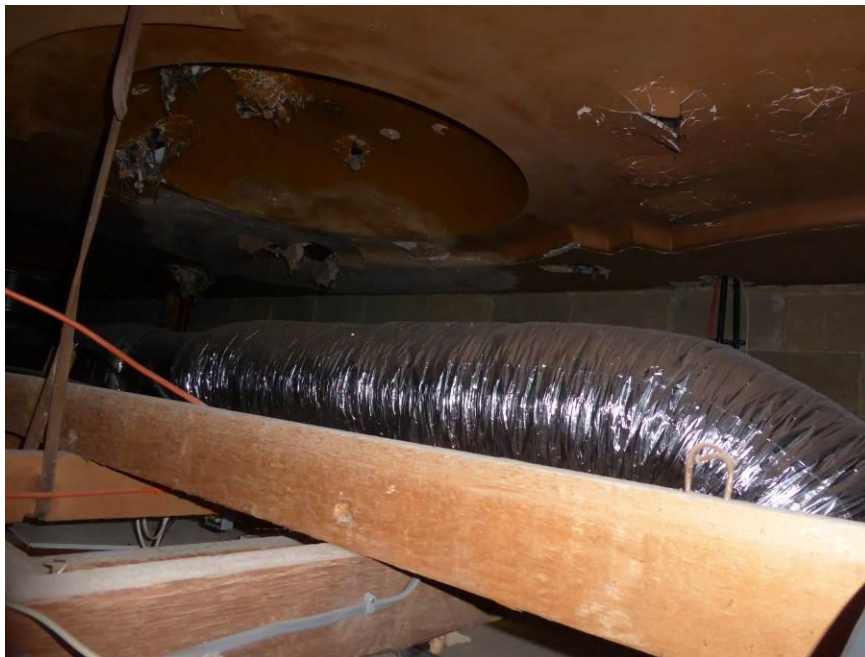
Due to limitations the condition of the suspended plastered ceiling could not be inspected in details. The visual inspection from below proved decorative features are installed in this area. We've also noted some damage on the historic ceiling with abraded / broken pieces of plaster remaining. These should be removed to prevent future failure. Staining / discolouration on the ceiling was observed, which can be evidence of historic water penetration through the roof covering (see picture on the next page). Considering the visual observation and findings in other areas, we think that condition of the ceiling must be inspected in details and this should include plain areas and decorative plasterwork.

Photo 32 – damaged underside of the ceiling over the Alemein Room.

- 5.7 Safe access in the loft area over the Alemein room is required. All insulation and debris need to be removed and the Asbestos survey done to confirm conditions of the safe access. Means of safe access to the vaulted ceilings on the sides of Auditorium need to be provided as well. The below access for detailed inspection should be organised by dismantling the tiled suspended ceiling locally and provision of ladder access to the ceiling level. Having the access organised, all loose / abraded / broken pieces of plaster ceiling should be removed to prevent failure in the future.

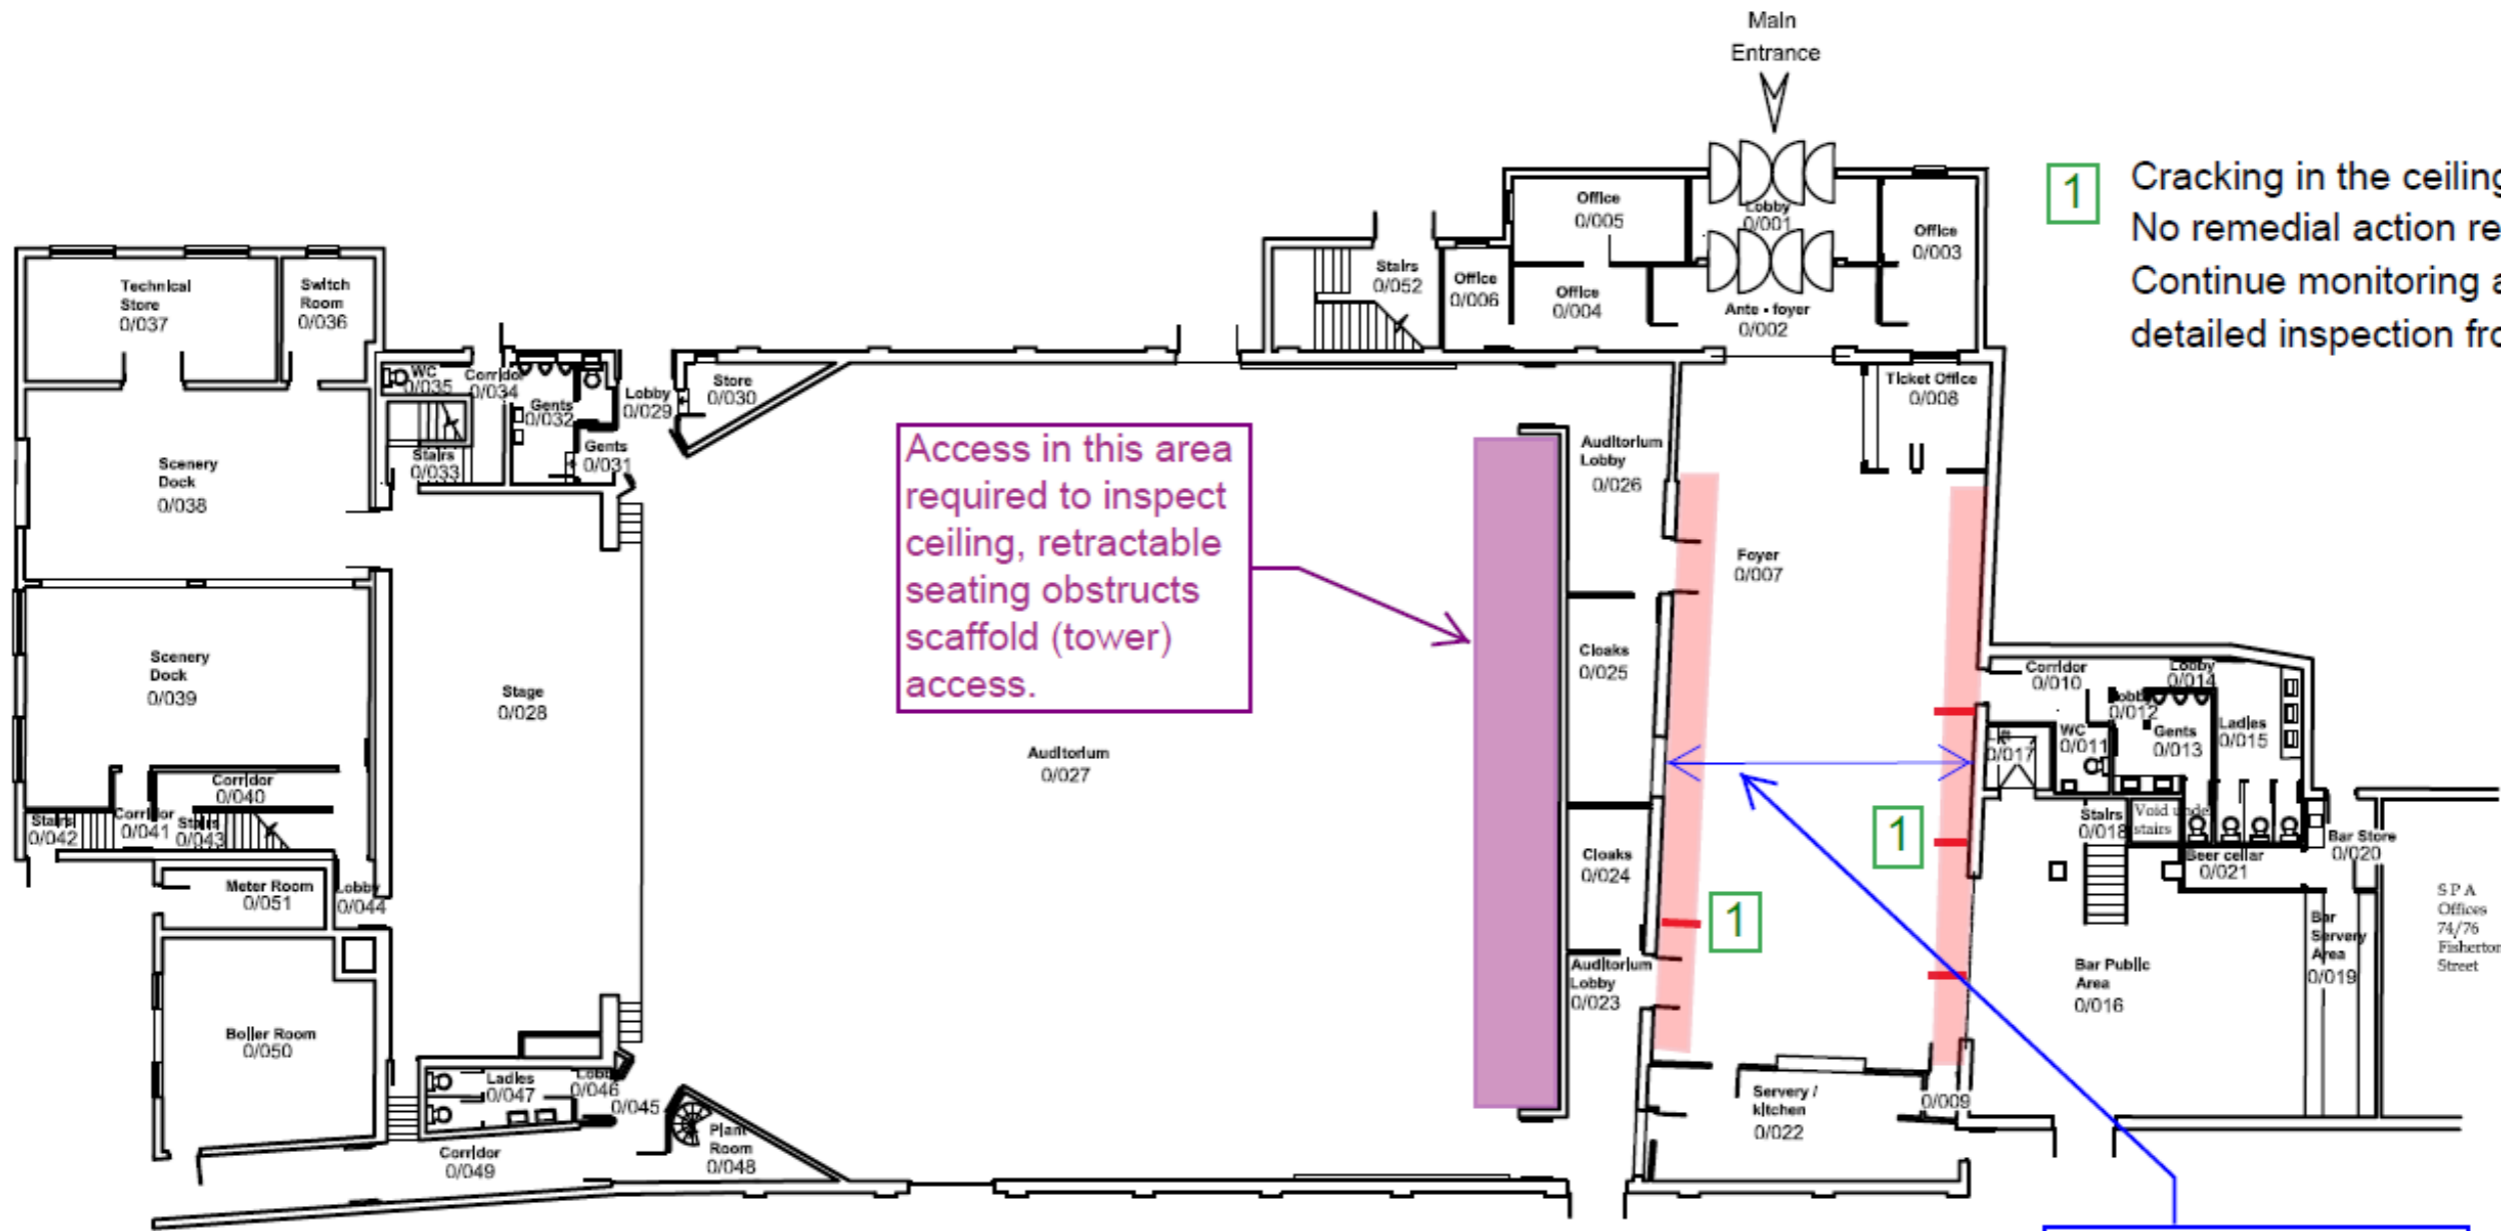
STRUCTURES AND DEFECTS CHART – GROUND FLOOR

Access in this area required to inspect ceiling, retractable seating obstructs scaffold (tower) access.

1 Cracking in the ceiling over Foyer. No remedial action required. Continue monitoring and allow for detailed inspection from above.

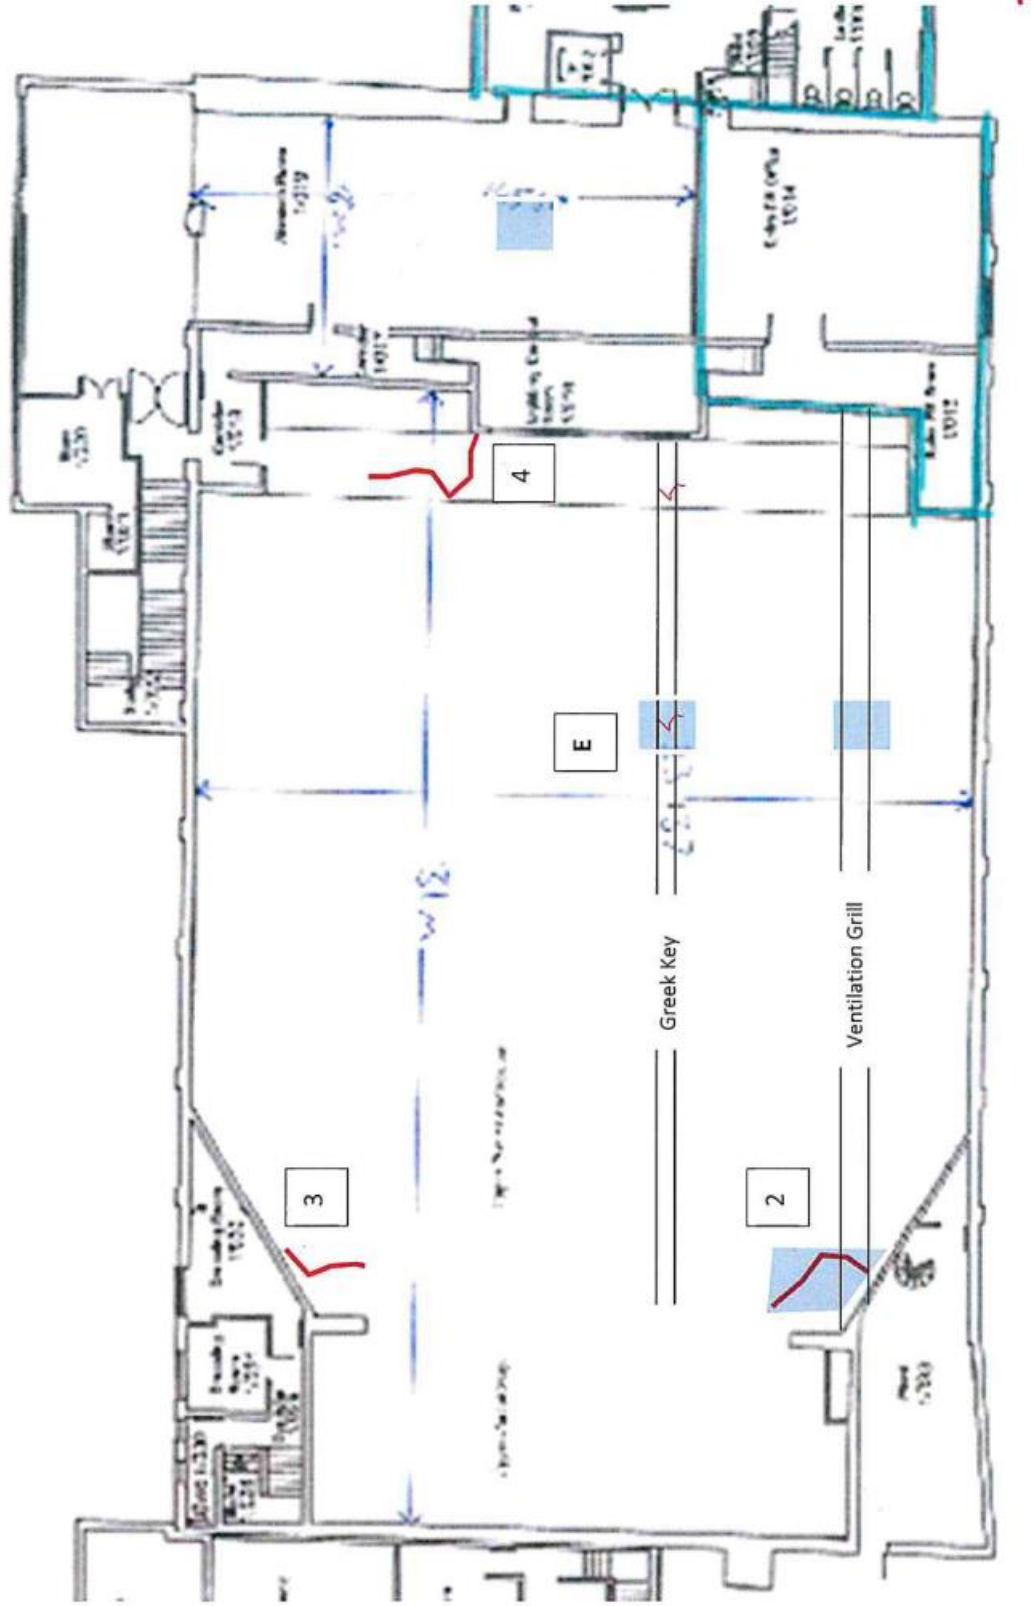
Figure 1 - 1st Floor RCP - Inspection from below

Location of Cracking
