Joint Waste Site  
Allocations Site  
Survey Report

Prepared for  
Wiltshire County Council  
Swindon Borough Council

August 2006

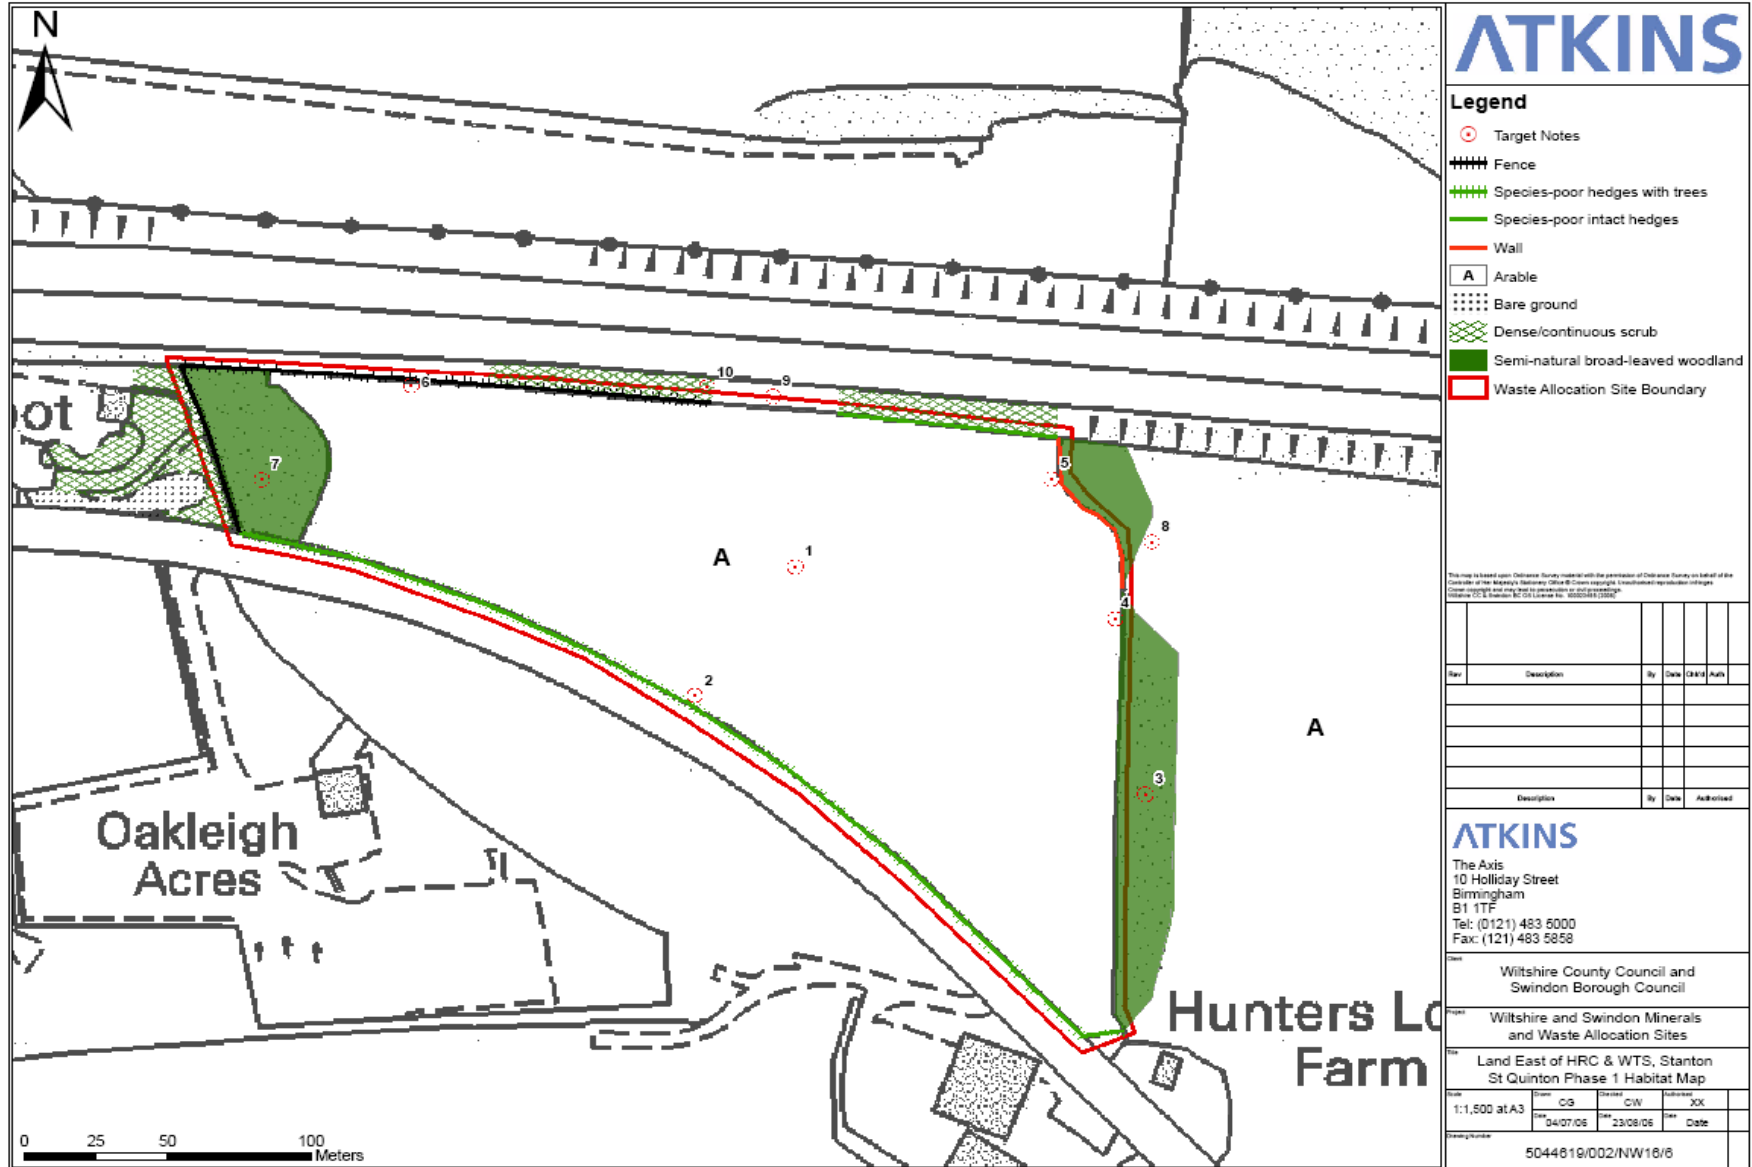
Phase 1 Habitat Map

Number	Target Note	Species Notes
1	Buffer strips at edge of arable field [approx 2-5m wide] between crop and hedgerow.	common cleavers, barren brome, soft brome, cranes bill, forget-me-not, poppy, cats-tail, ground ivy,
2	Badger latrine by hedgerow.	
3	Rabbit activity noted	sycamore [semi-mature], ash [semi-mature], hawthorn shrubs, ivy ground cover, nettle, some blue bells, lords and ladies
4	Large, mature oak tree. Ivy covered trunk. Lots of broken and split limbs with peeling bark. Medium to high bat potential.	
5	Mature sycamore. Ivy covered trunk. Low to medium bat potential	
6	Line of 15 to 20 young, semi-mature ash trees located outside site (within highways boundary).	
7	Semi mature woodland, appears semi-natural although the younger trees present suggest it could be plantation. Recommend woodland is kept [will act as screen and maintain biodiversity value of site]. Rabbit activity noted in woodland [no badgers].	sycamore, ash, wych elm, hawthorn, ivy ground cover with bluebells, common cleavers, ground ivy, herb robert

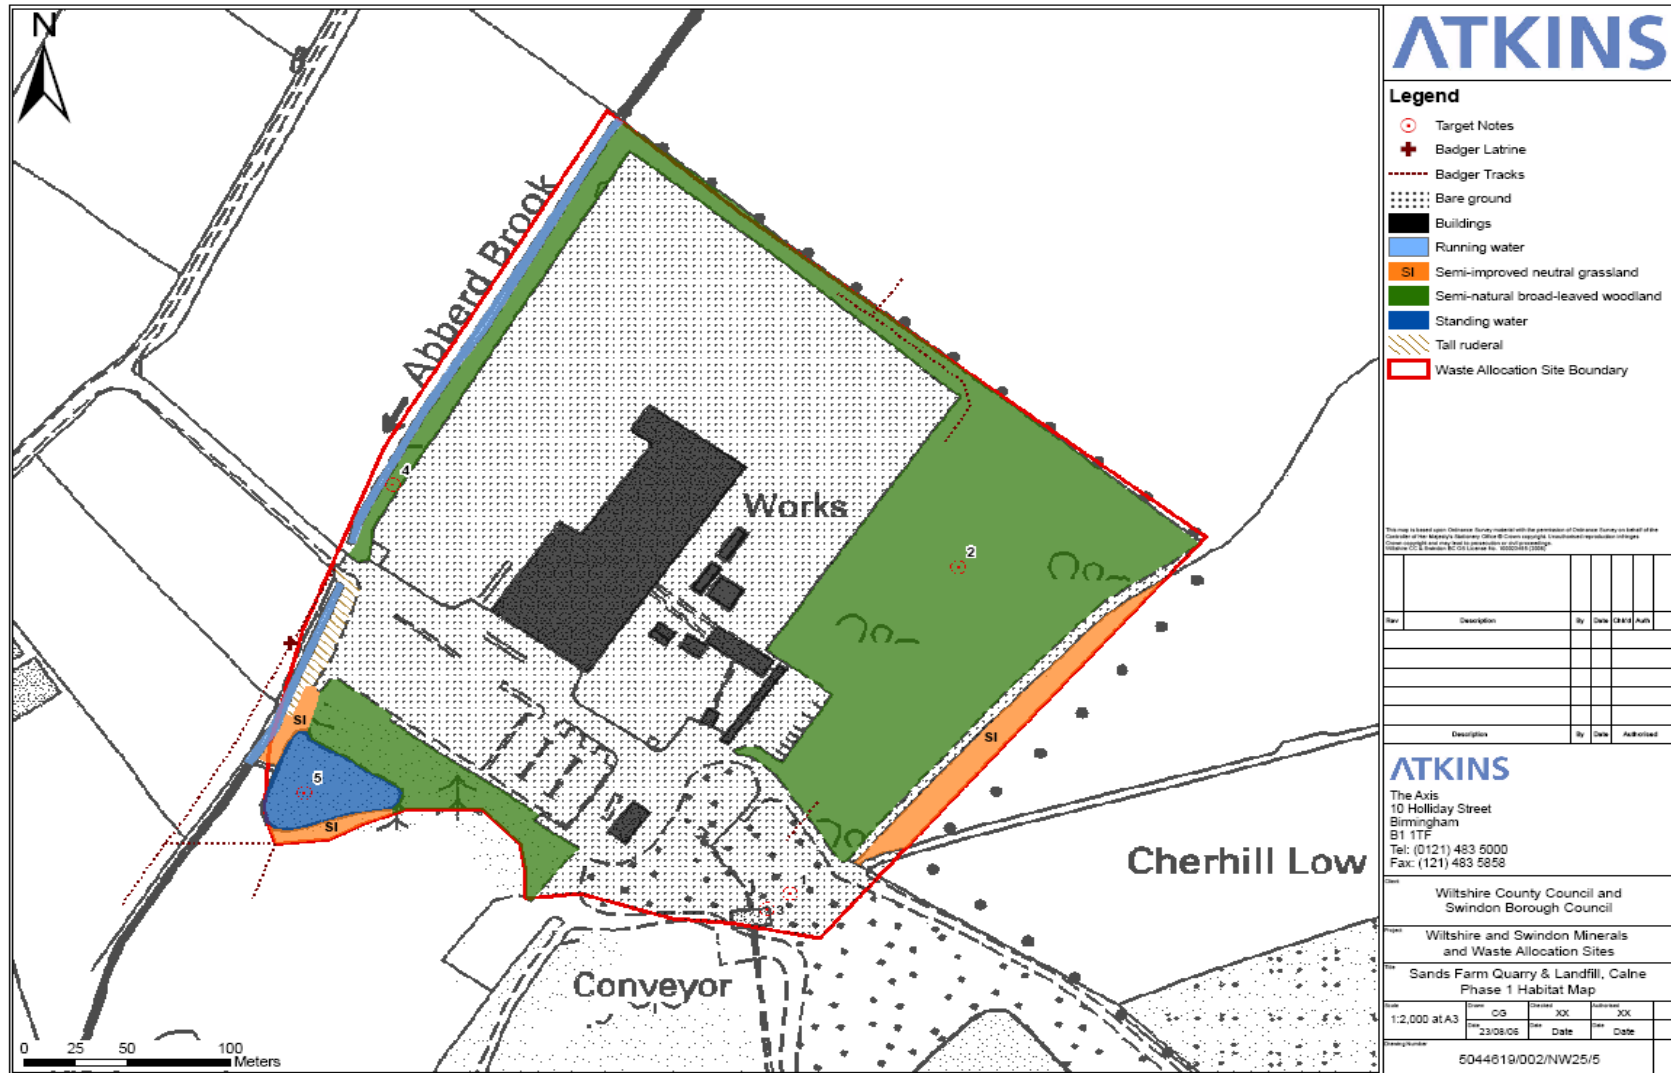
Phase 1 Habitat Map

Number	Target Note	Species Notes
1	Sand and gravel processing area	
2	Very dense unmanaged woodland, impenetrable in parts, very dark and shaded with thick shrub layer.	Common hawthorn, oak, bird cherry, ash, hazel, field maple, common nettle, curled dock, broad-leaved dock, meadow vetchling, hogweed, bramble, bird's-foot trefoil, coltsfoot, mugwort, yarrow, red dead nettle. Mammal tracks present mainly deer and also deer laying-up areas but also some badger tracks (no latrines found within the wood but badger latrine on edge of wood).
3	Large 3-sided bund made of high sandstone walls containing pooled standing water which was very choked with vegetation but had areas of open water. Water surrounded by brick rubble.	Water milfoil, spike rush, horsetail, lesser reed mace, goat willow (saplings), sweet grass. Lots of damselflies observed and water body suitable for amphibians including great crested newt.

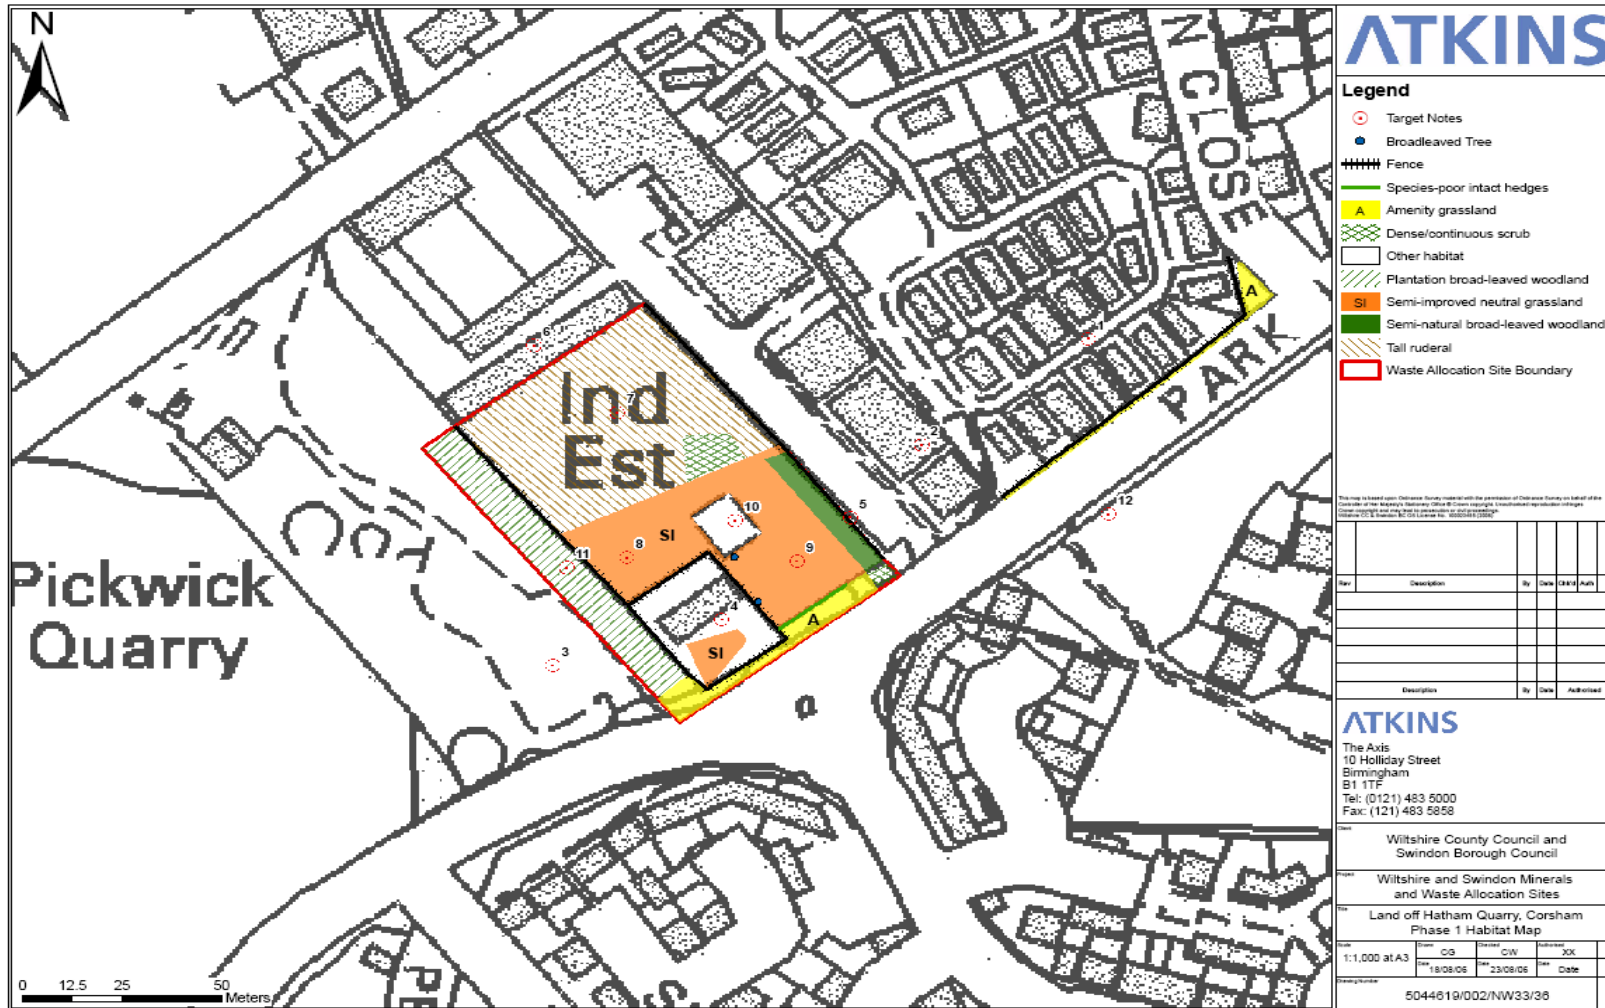
Phase 1 Habitat Map

Number	Target Notes	Species Notes
1	Caravan park	
2	Modern breeze block factory buildings. No access. Low bat potential	
3	Hanson Hartham Park Quarry. Large blocks of sandstone present in bare earth yard.	
4	Private residence. One storey stone block bungalow with sloping tiled roof. Building in good condition with low bat potential. Garden consists of area of unmown grass and gravel.	
5	Overgrown, unmanaged hedgerow. 5m wide	willow , elder, buddleia
6	Modern factory building. Breeze blocks with metal cladding. Gently sloping roof. Low bat potential.	
7	Very dense, tall veg interspersed with grass (cock's-foot and false oat grass)	spear mint, rosebay willow herb [lots] , dogwood saplings, bramble, ox-eye daisy, nettle, dock, hogweed, creeping. buttercup
8	Mounds covered in nettle	
9	Rough grassland area. Vegetation grown on waste land and as such scrubby.	red clover, ribwort plantain, ox-eye daisy, thistle, cranes bioo, d0oci, creeping buttercup, common vetch, false oat grass, bramble, rosebay willowherb, bindweed, yorkshire fog,

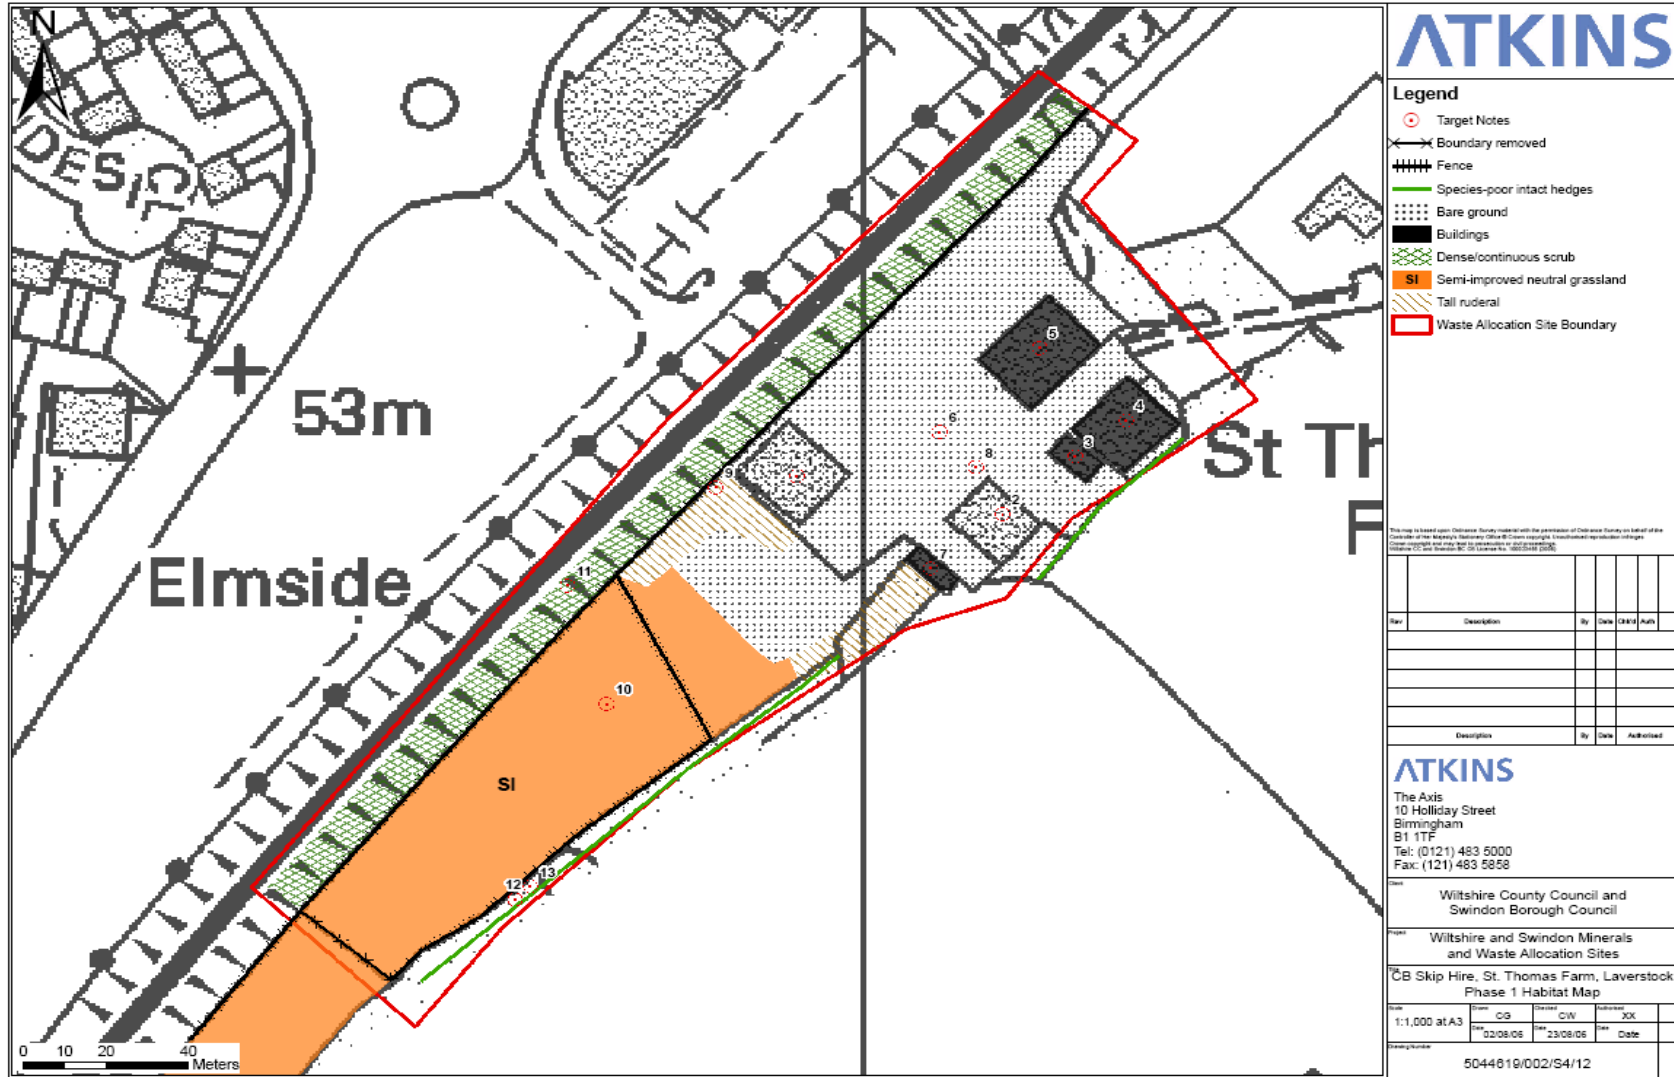
Phase 1 Habitat Map

Number	Target Notes	Species Notes
1	Building gone	
2	Building gone	
3	Small breeze block building with asbestos roof. There is a gap between roof and walls. Low bat potential.	
4	Breeze block barn (half breeze block, half wood planks). Very open and exposed with pitched asbestos roof. Low bat potential.	
5	Large breeze block barn (half breeze block, half wooden planks) with sloping asbestos roof. Very open and exposed. Low bat potential.	
6	Skip hire yard - in use. Bare earth with lots of skips present. Small portacabin present in centre of the site.	large numbers of house martins seen flying above yard, may be nesting on barn buildings present within the site.
7	Small breeze block building with sloping asbestos roof. Very open and exposed. Low bat potential	
8	Portacabin	
9	Tall ruderal	nettle, evening primrose, thistle, dock, hogweed, scen5ed mayweed, poppy
10	Semi-improved grassland field used for pasture (grazing horses).

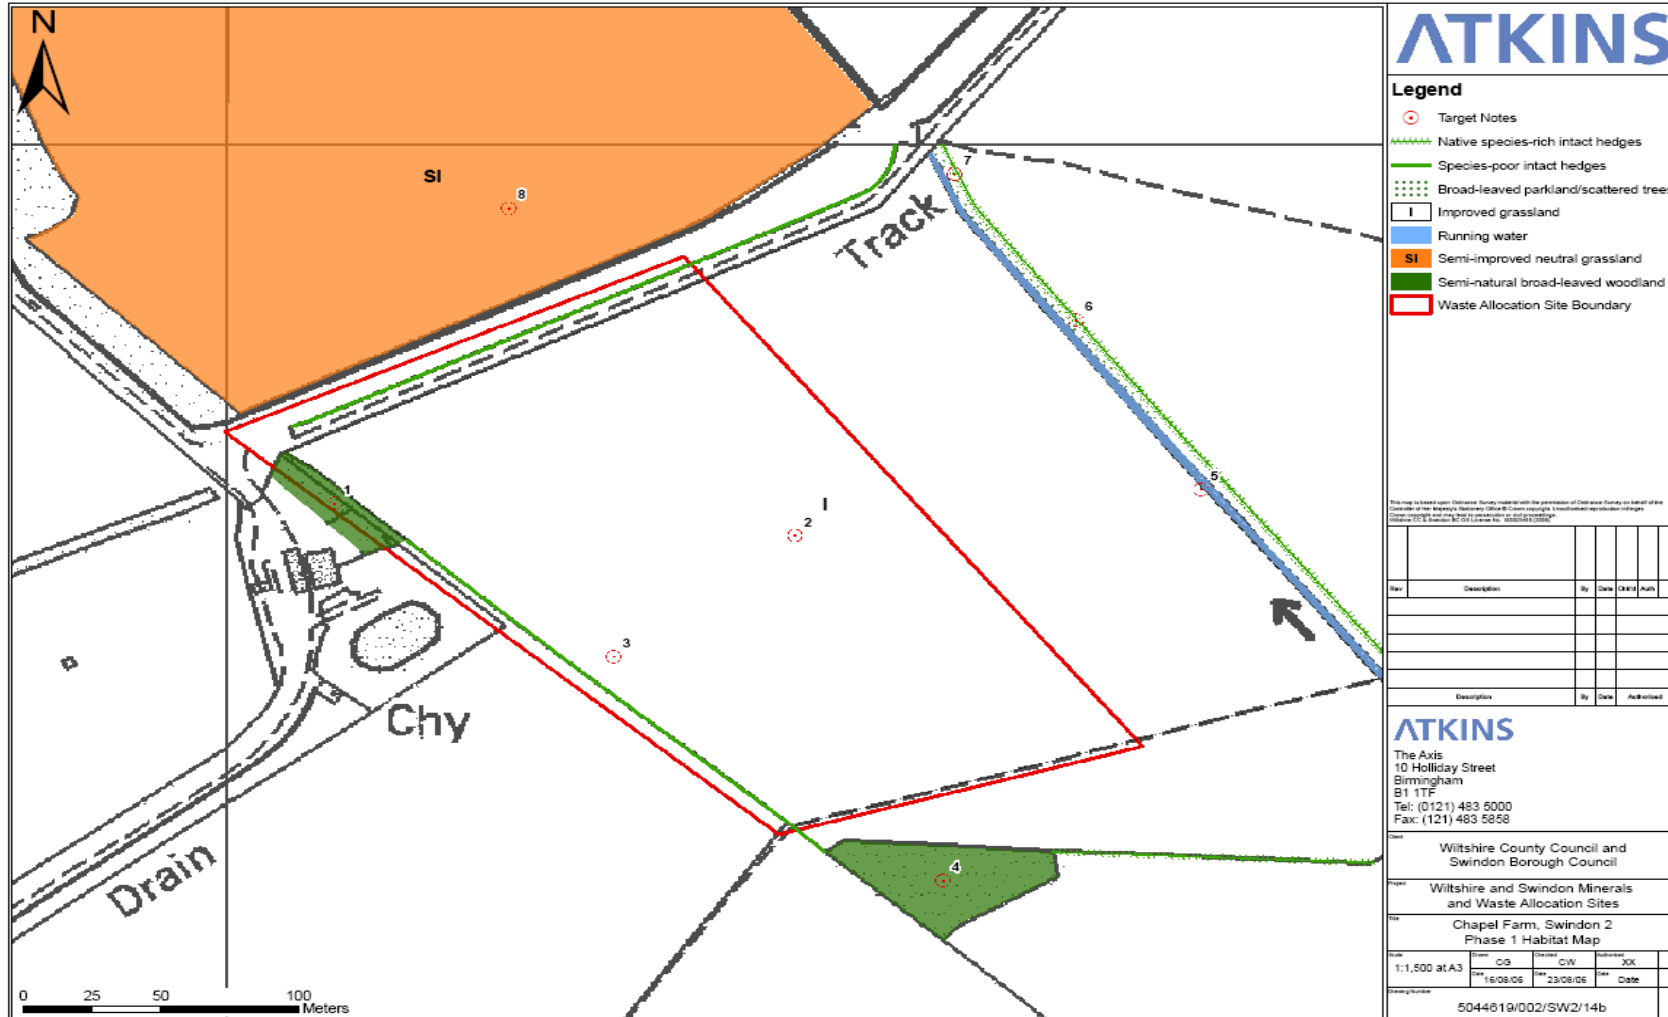
Phase 1 Habitat Map

Number	Target Notes
1	Semi-mature broadleaved woodland strip. Consists of willow, hawthorn, ash and some elder. All trees are generally semi-mature and young with a low potential to support roosting bats. The understory consists of cow parsley, bramble, dock, common cleavers, nettle, dog rose and hogweed. An area of unmown grassland approximately 3m wide is present in front of the woodland (within the site). Species present include common cleavers, dock, hogweed, thistle, bramble, false oat-grass, Timothy and great horsetail.
2	Improved grassland field which has been recently mown for haylage. Majority of the field is flat.
3	Sighting of a brown hare.
4	Small area of semi-mature broadleaved woodland. Consists of field maple, hawthorn, ash, oak with a 2m wide strip of nettles in the field in front of the woodland. Woodland not surveyed as fencing prevented access
5	Wet ditch at the base of the hedgerow. Very little water present (less than 5cm) and moving very slowly. The ditch has gently sloping banks and a muddy substrate. No aquatic, marginal or emergent vegetation present for majority of ditch, however northern end of ditch becomes choked with reed canary grass and rushes. Ditch has a low potential for water voles and white-clawed crayfish. This ditch may support breeding populations of great crested newts.

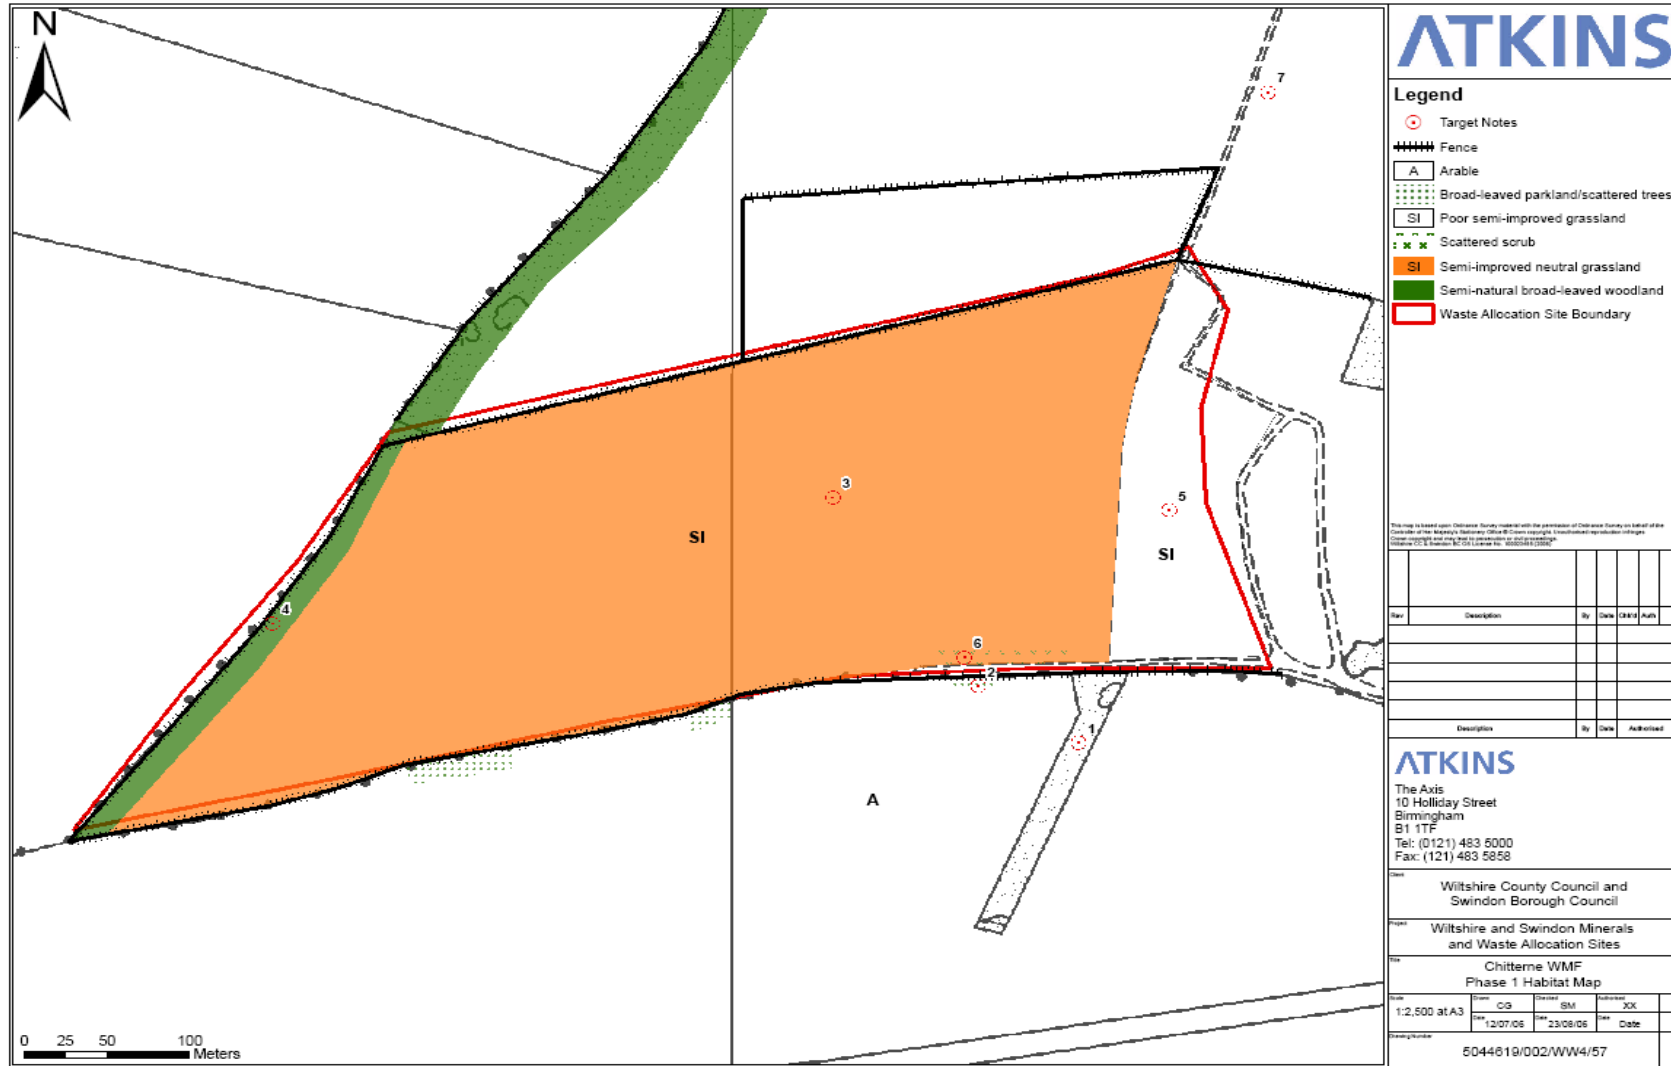
Phase 1 Habitat Map

Number	Target Notes	Species Notes
1	Mixture of broad-leaved and Scot's pine trees	
2	Very large mature beech trees	
3	Semi-improved grassland - cow grazed	Scentless mayweed, white clover, creeping buttercup, spear thistle, scarlet pimpernel and mainly perennial rye-grass
4	Band of native trees and shrubs forming un-managed thick hedge - good bird nesting habitat	Hawthorn, larch, mature beech and elder
5	Rougher area of grassland, same species as TN 3 but more thistle plus others	Scentless mayweed, white clover, creeping buttercup, spear thistle, scarlet pimpernel and mainly perennial rye-grass plus black medick, Yorkshire fog and some common dock
6	Area of un-managed scrub and grassland where rough track ends (possibly access area if site used). Piles of rubble make this good reptile habitat.	Cock's foot, false oak and bent sp. grasses, dog rose, hog weed, teasel, bramble, lots of butterflies
7	Owl pellet on rough track
