Condition Survey Report

Salisbury Library

March 2023

Wiltshire Council

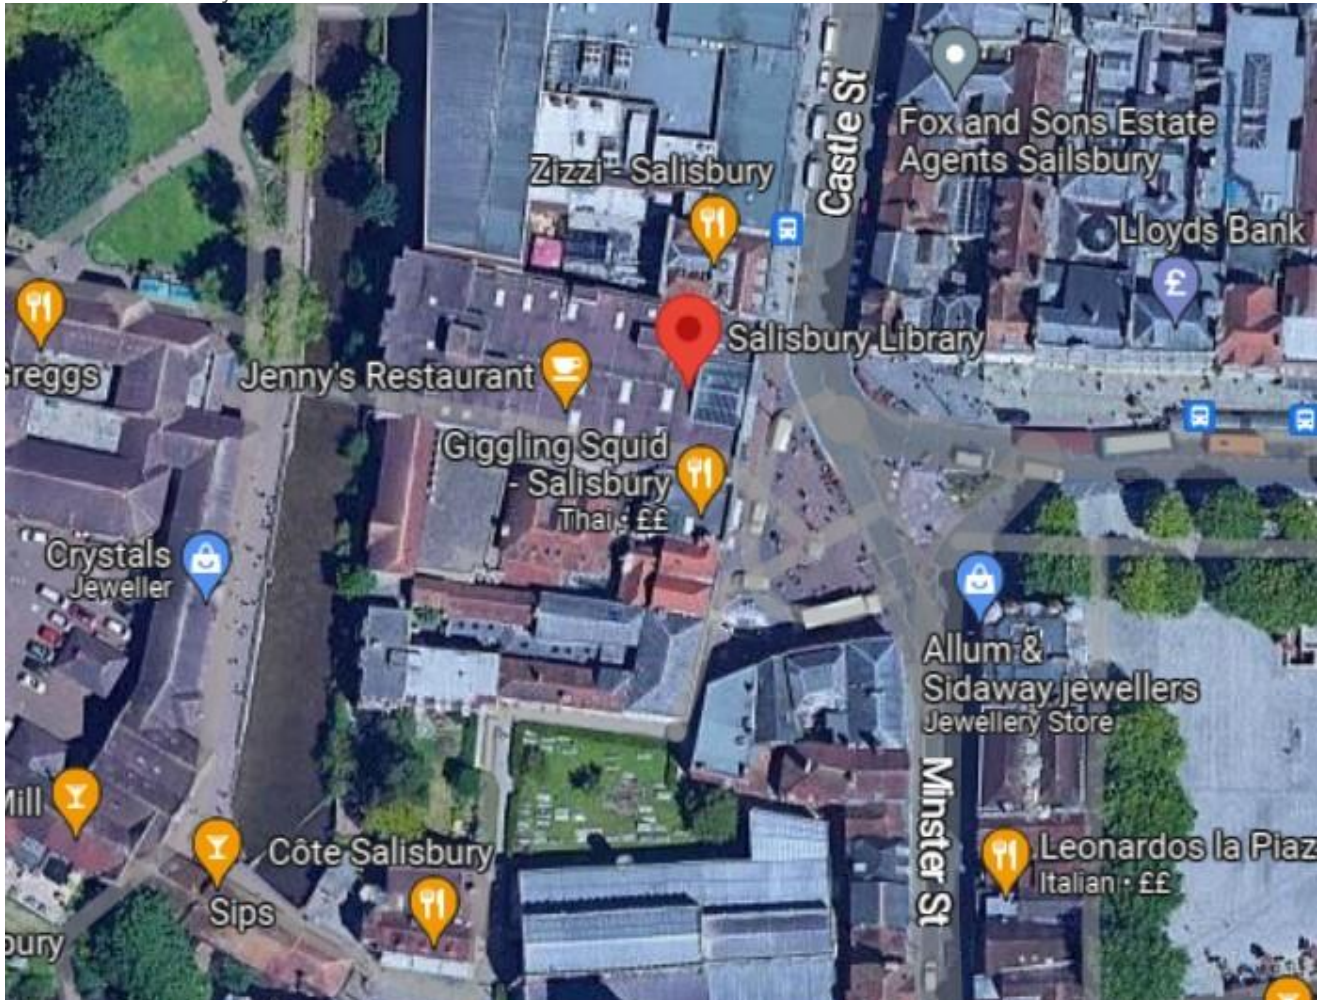
The site is located within the centre of Salisbury city opposite the Salisbury market square. The site is accessed by public footpaths run around the east and south elevation and by vehicle from Castle Street. The site sits within the Salisbury Conservation Area.

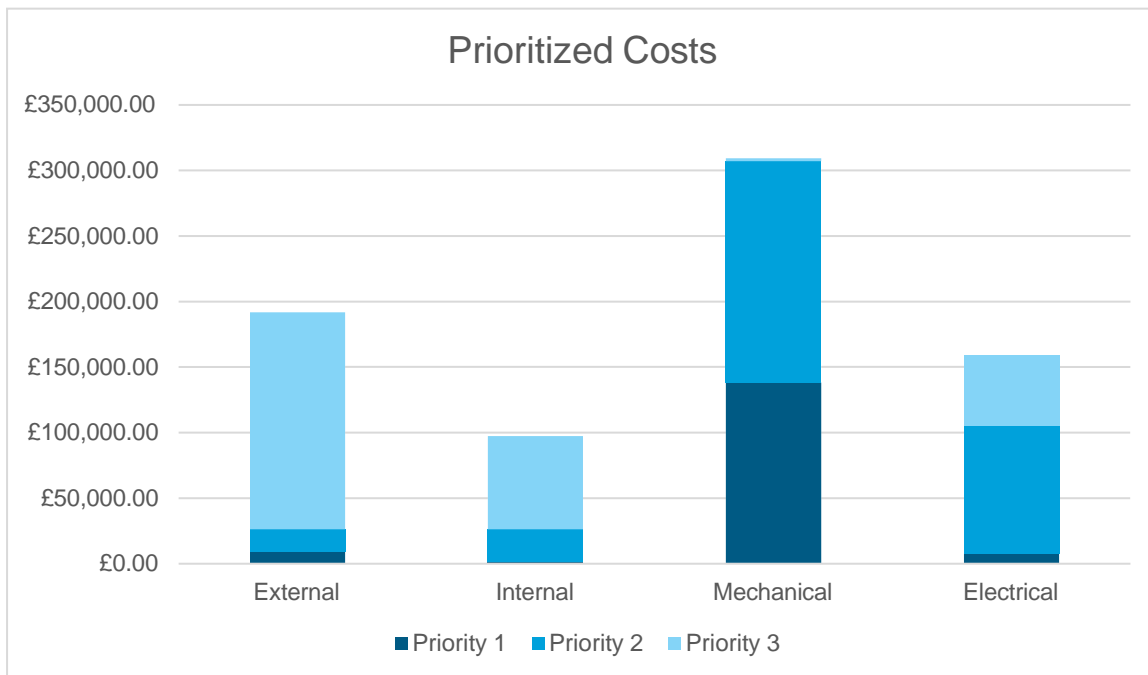
| Area / Element | Priority 1 | Priority 2 | Priority 3 | Total |
|---|---|---|---|---|
| Electrical | £7,810.00 | £97,915.50 | £53,373.00 | £159,058.50 |
| Totals | £156,820.40 | £308,623.58 | £292,168.70 | £757,612.68 |
